The More You Know

February 21, 2024

Too Much Heat? You Need To "Sweat" The Details!

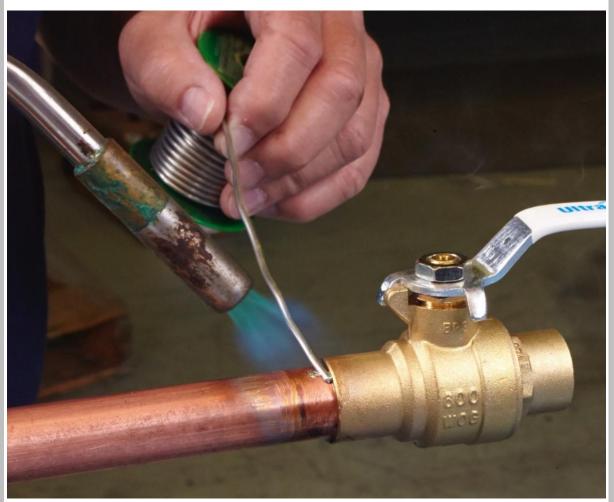
Did You Know... The temperatures associated with soldering can have an impact on the ability of the stem seals to do their job. This is due to the potential expansion and contraction of the metals, as well as distortion of the seals at these elevated temperatures. When soldering (or "sweating") a ball valve into place, the valve's packing nut should be inspected during the system test and adjusted as required.

Milwaukee Valve UltraPure Ball Valve being soldered into a system.

If adjustments are required, this **IS NOT** indicative of a defective valve, especially if excessive heat is applied during the install. This applies to all Milwaukee Valve brass and bronze ball valves; including the BA-150/450/350 series and the BA-485B, and is referenced in the **Installation and Operation manuals** for these solder-end valves.

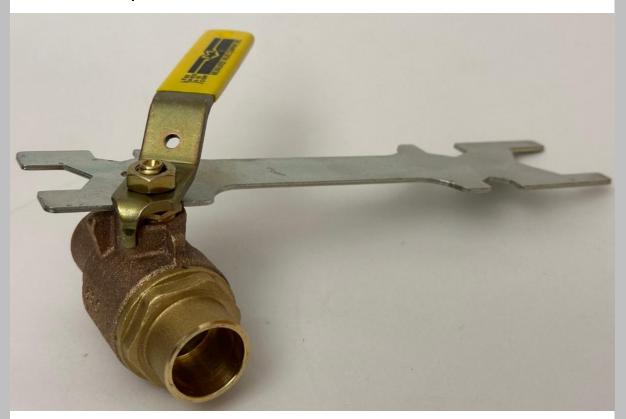
Milwaukee Valve Bronze Ball Valve with Packing Nut Wrench

8) Verify the tightness of the packing nut, after installation and valve cools.

8. Heat from soldering, if excessive, may affect stem seal. After completion of soldering, it may be necessary to tighten packing gland. Always check for leakage after installation.

• Tightening of the stem packing after soldering may be required.
